**Jurisdictional Delineation of Waters
of the U.S.**

Hercules Intermodal Transit Center

Jurisdictional Delineation of Waters of the United States

**HDR Engineering, Inc.
1610 Arden Way, Suite 175
Sacramento, CA 95815
(916) 569-1000
Contact: Serge Stanich**

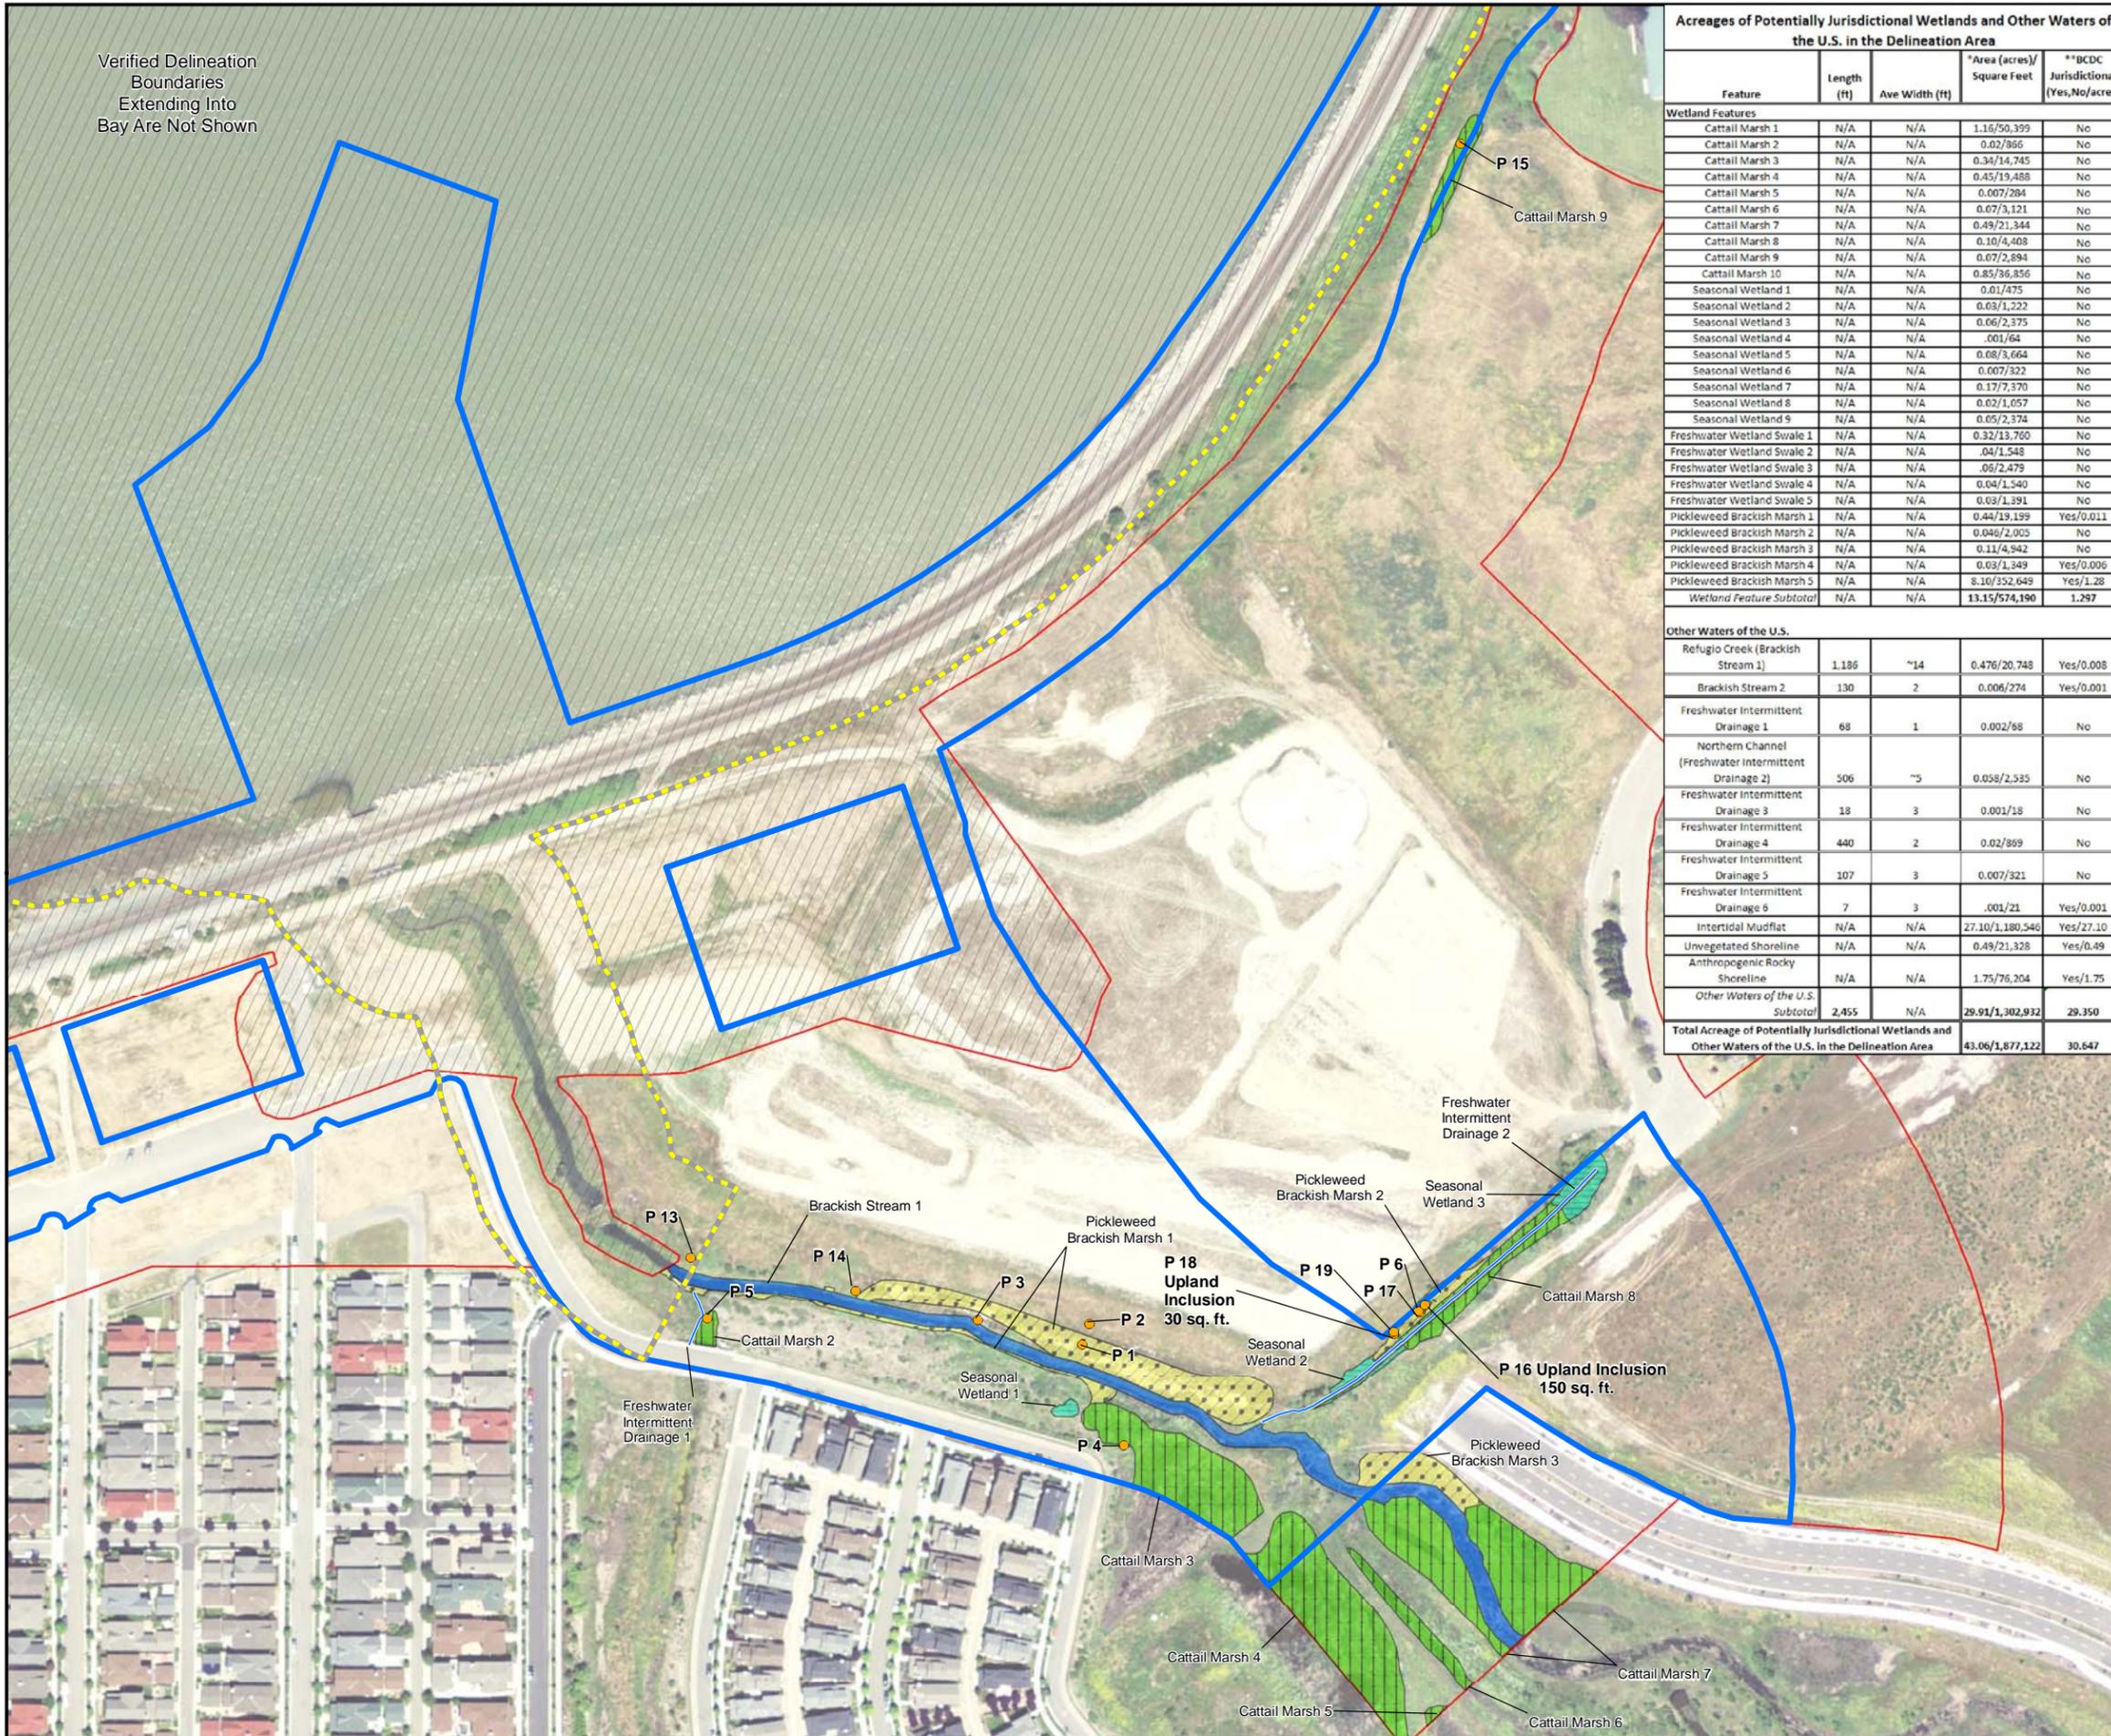
Figure 6-C: Delineation Map
 Delineators: Stephen Stringer, LaTisha Burnaugh, Sean Marquis, and Mark Ashenfeller
 Survey Dates: December 8, 2009; December 29, 2009; March 31, 2010; September 14, 2010; and September 20, 2010

Feature	Length (ft)	Ave Width (ft)	*Area (acres)/ Square Feet	**BCDC Jurisdictional (Yes,No/acres)
Wetland Features				
Cattail Marsh 1	N/A	N/A	1.16/50,399	No
Cattail Marsh 2	N/A	N/A	0.02/866	No
Cattail Marsh 3	N/A	N/A	0.34/14,745	No
Cattail Marsh 4	N/A	N/A	0.45/19,488	No
Cattail Marsh 5	N/A	N/A	0.007/284	No
Cattail Marsh 6	N/A	N/A	0.07/3,121	No
Cattail Marsh 7	N/A	N/A	0.49/21,344	No
Cattail Marsh 8	N/A	N/A	0.10/4,408	No
Cattail Marsh 9	N/A	N/A	0.07/2,894	No
Cattail Marsh 10	N/A	N/A	0.85/36,856	No
Seasonal Wetland 1	N/A	N/A	0.01/475	No
Seasonal Wetland 2	N/A	N/A	0.03/1,222	No
Seasonal Wetland 3	N/A	N/A	0.06/2,375	No
Seasonal Wetland 4	N/A	N/A	.001/64	No
Seasonal Wetland 5	N/A	N/A	0.08/3,664	No
Seasonal Wetland 6	N/A	N/A	0.007/322	No
Seasonal Wetland 7	N/A	N/A	0.17/7,370	No
Seasonal Wetland 8	N/A	N/A	0.02/1,057	No
Seasonal Wetland 9	N/A	N/A	0.05/2,374	No
Freshwater Wetland Swale 1	N/A	N/A	0.32/13,760	No
Freshwater Wetland Swale 2	N/A	N/A	.04/1,548	No

Freshwater Wetland Swale 3	N/A	N/A	.06/2,479	No
Freshwater Wetland Swale 4	N/A	N/A	0.04/1,540	No
Freshwater Wetland Swale 5	N/A	N/A	0.03/1,391	No
Pickleweed Brackish Marsh 1	N/A	N/A	0.44/19,199	Yes/0.011
Pickleweed Brackish Marsh 2	N/A	N/A	0.046/2,005	No
Pickleweed Brackish Marsh 3	N/A	N/A	0.11/4,942	No
Pickleweed Brackish Marsh 4	N/A	N/A	0.03/1,349	Yes/0.006
Pickleweed Brackish Marsh 5	N/A	N/A	8.10/352,649	Yes/1.28
Wetland Feature Subtotal	N/A	N/A	13.15/574,190	1.297
Other Waters of the U.S.				
Refugio Creek (Brackish Stream 1)	1,186	~14	0.476/20,748	Yes/0.008
Brackish Stream 2	130	2	0.006/274	Yes/0.001
Freshwater Intermittent Drainage 1	68	1	0.002/68	No
Northern Channel (Freshwater Intermittent Drainage 2)	506	~5	0.038/2,535	No
Freshwater Intermittent Drainage 3	18	3	0.001/18	No
Freshwater Intermittent Drainage 4	440	2	0.02/869	No
Freshwater Intermittent Drainage 5	107	3	0.007/321	No
Freshwater Intermittent Drainage 6	7	3	.001/21	Yes/0.001

Intertidal Mudflat	N/A	N/A	27.10/1,180,546	Yes/27.10
Unvegetated Shoreline	N/A	N/A	0.49/21,328	Yes/0.49
Anthropogenic Rocky Shoreline	N/A	N/A	1.75/76,204	Yes/1.75
Other Waters of the U.S. Subtotal	2,455	N/A	29.91/1,302,932	29.350
Total Acreage of Potentially Jurisdictional Wetlands and Other Waters of the U.S. in the Delineation Area	43.06/1,877,122			30.647

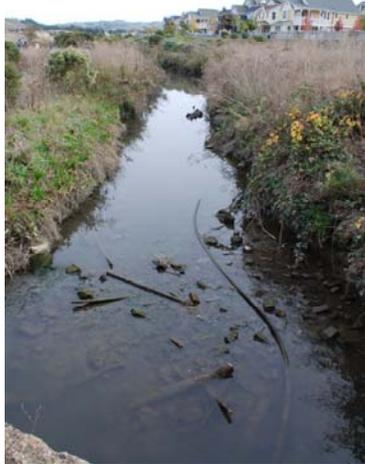
Photo 1. View looking upstream along Refugio Creek (Brackish Stream 1) (11/10/09).

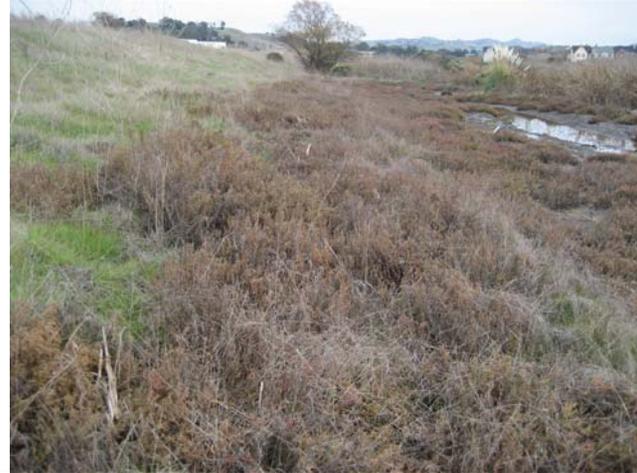
Photo 2. View looking east along the northern border of Brackish Marsh 1, taken near data point P1. Tree in background is associated with Brackish Marsh 2 (12/08/09).

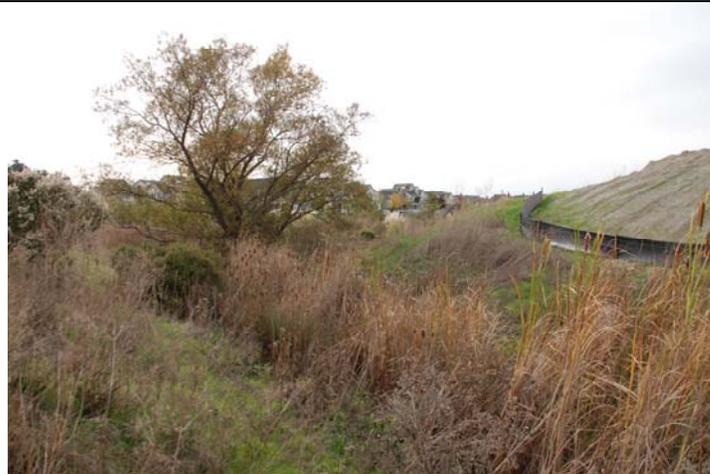
Photo 3. View looking southwest at Northern Channel. Photo taken near southwest end of Northern Channel (11/10/09).

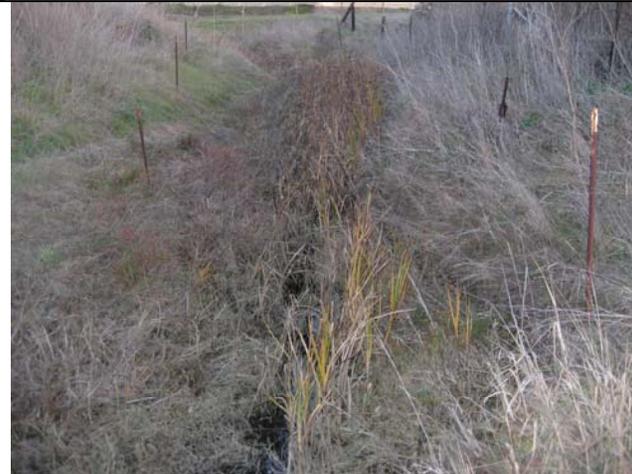
Photo 4. View looking east along Brackish Stream 2 and Brackish Marsh 4 (12/08/09).

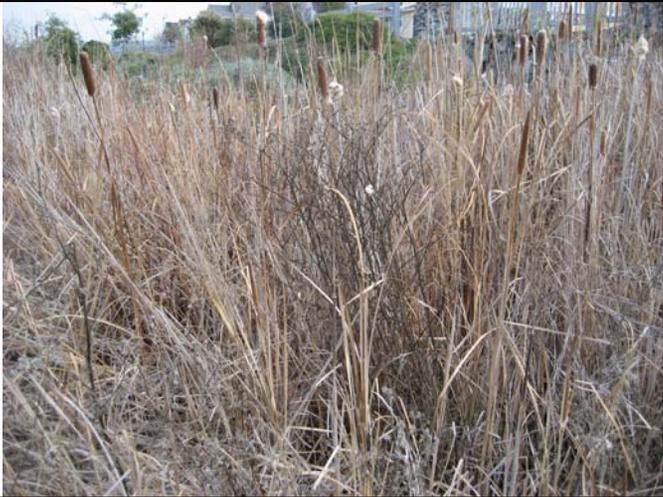
Photo 5. View of Seasonal Wetland 1 looking east (12/08/09).

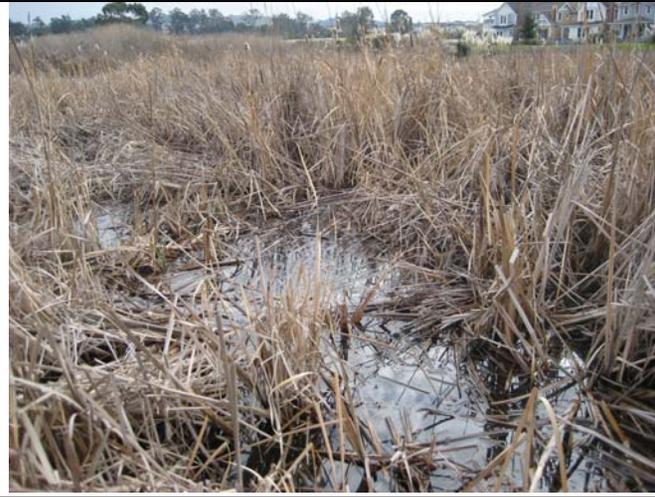
Photo 6. View of Seasonal Wetland looking south. Photo taken near data point P4 (12/08/09).

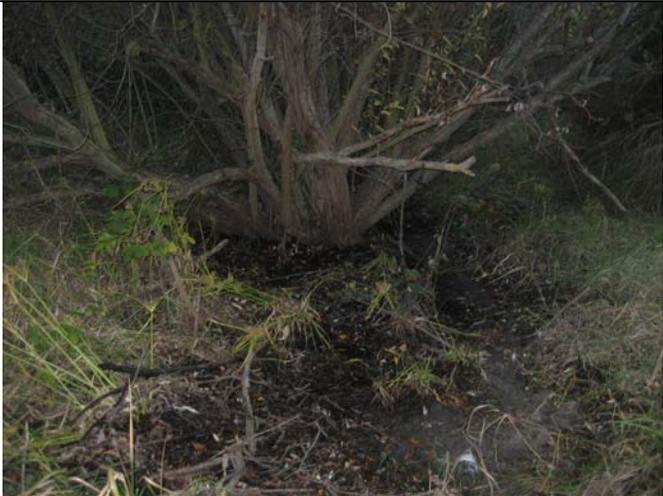
Photo 7. View of Seasonal Wetland 3 looking southwest (12/08/09).

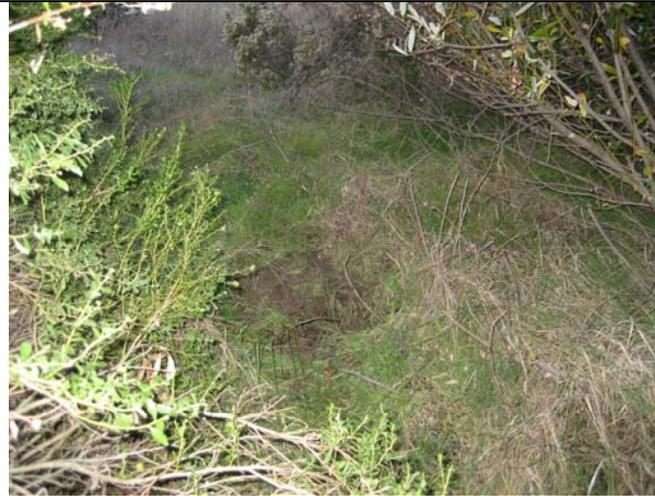
Photo 8. View of Freshwater Intermittent Drainage 1 looking southeast (upstream) (12/08/09).

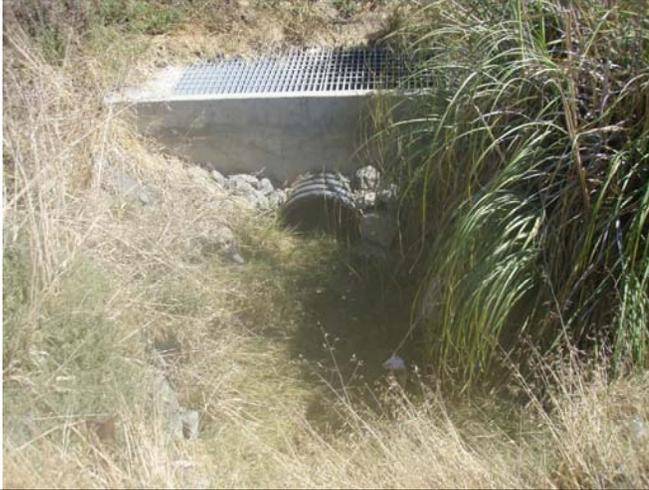
Photo 9. View of culvert at Freshwater Intermittent Drainage 6, looking east (9/14/10).

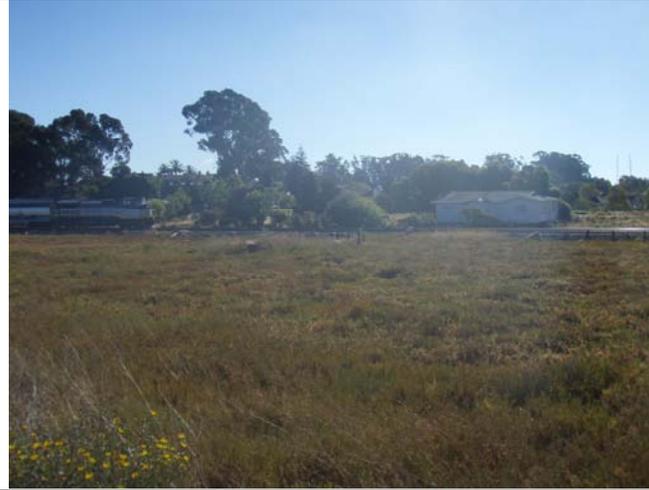
Photo 10. View of Pickleweed Brackish Marsh 5 looking east (9/20/10).

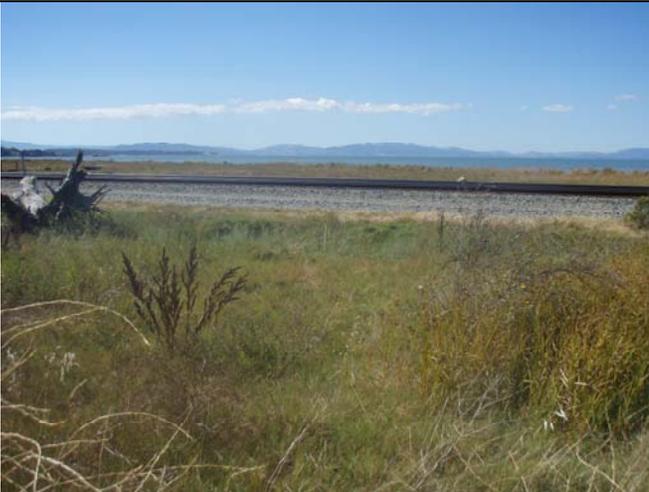
Photo 11. View of Seasonal Wetland 5 looking southwest (9/20/10).

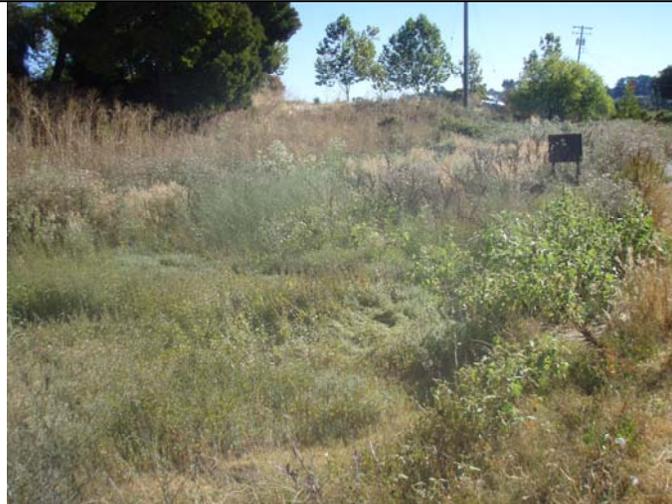
Photo 12. View of Seasonal Wetland 7 looking southeast (upstream) (12/08/09).

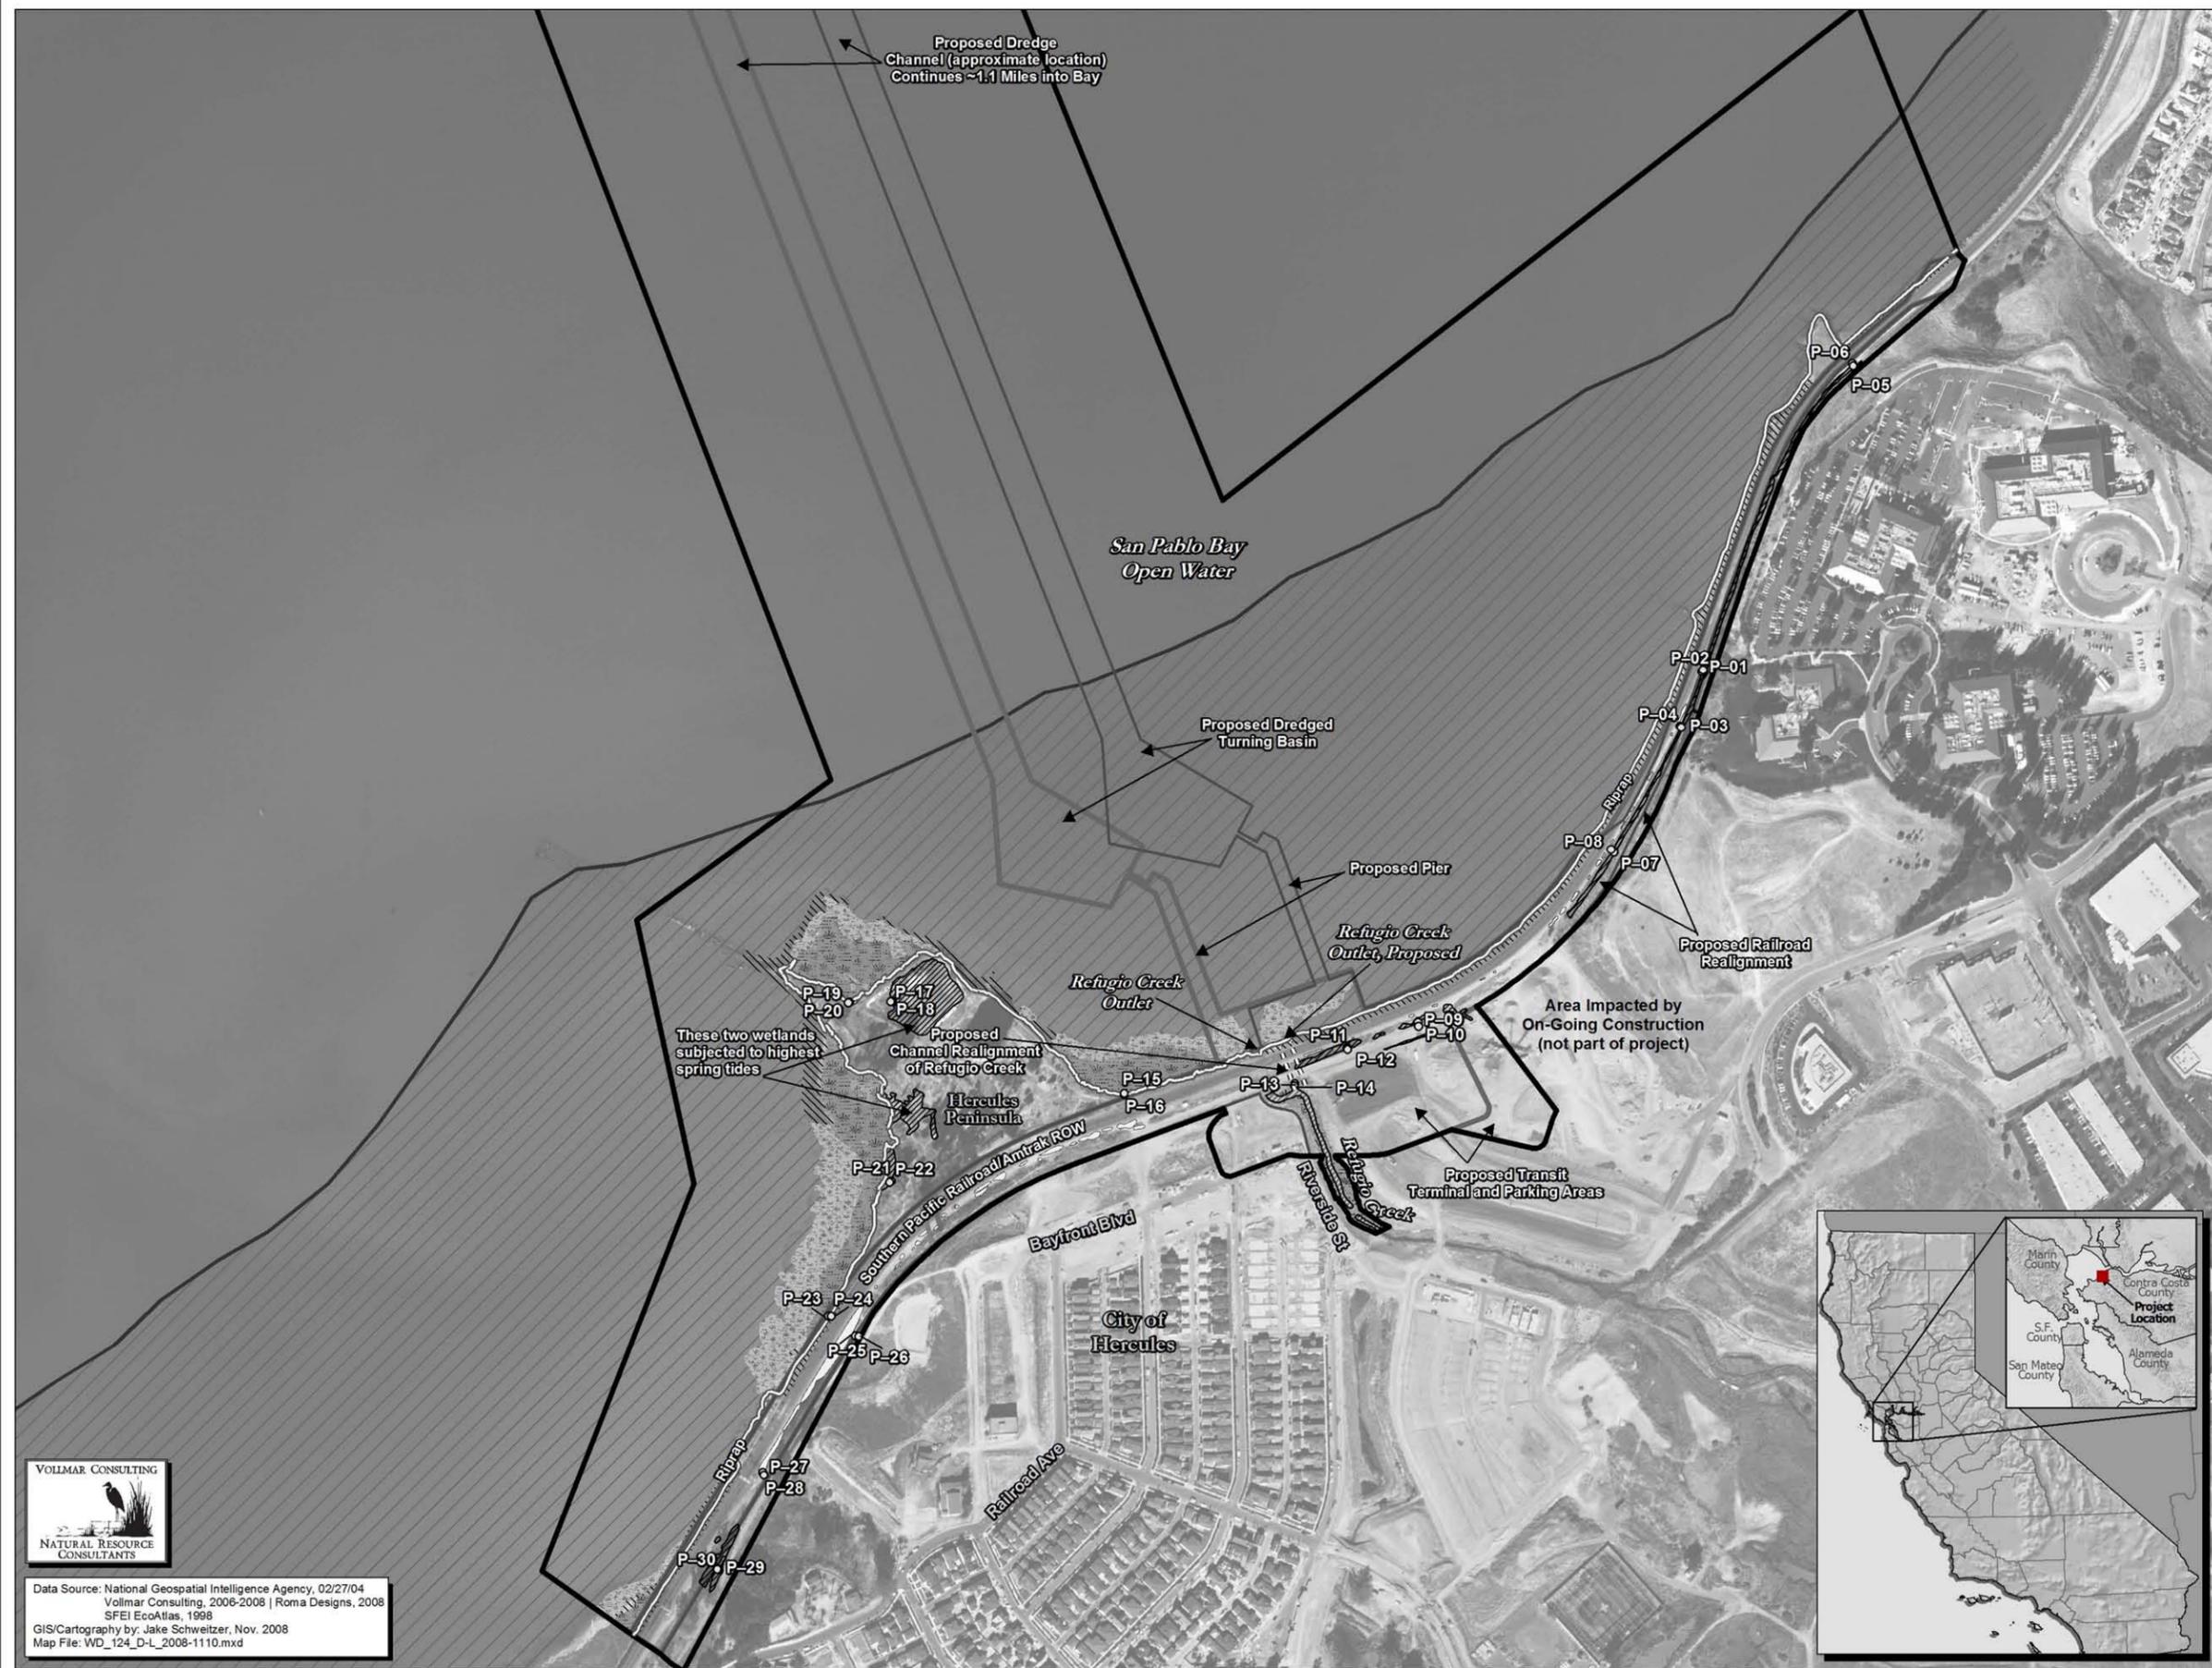
FIGURE 3
Jurisdictional
Waters of the U.S. 2007-2008
 Hercules Intermodal Transit Facility
 Contra Costa County, California

- Wetland Delineation Point (with ID #)¹
- ══ Mean High Water²
- ▭ Project Area (402 acres as mapped)
- ▨ California Cordgrass Tidal Marsh (4.152 ac.)
- ▨ Pickleweed Tidal Marsh (5.230 ac.)
- ▨ Freshwater Wetland (1.780 ac.)
- ▭ Bay Open Waters (approx 263.216 ac.)
- ▭ Other Waters (0.455 ac.)³
- ▭ Refugio Creek Open Water (0.191 ac.)⁴
- ▨ Intertidal Mudflats (EcoAtlas) (97.731 ac.)
- ▨ Anthropogenic Rocky Shoreline
- ▭ Alternative 1 Impact Area (approx. 42.5 acres)
- ▭ Alternative 2 Impact Area (approx. 42.5 acres)

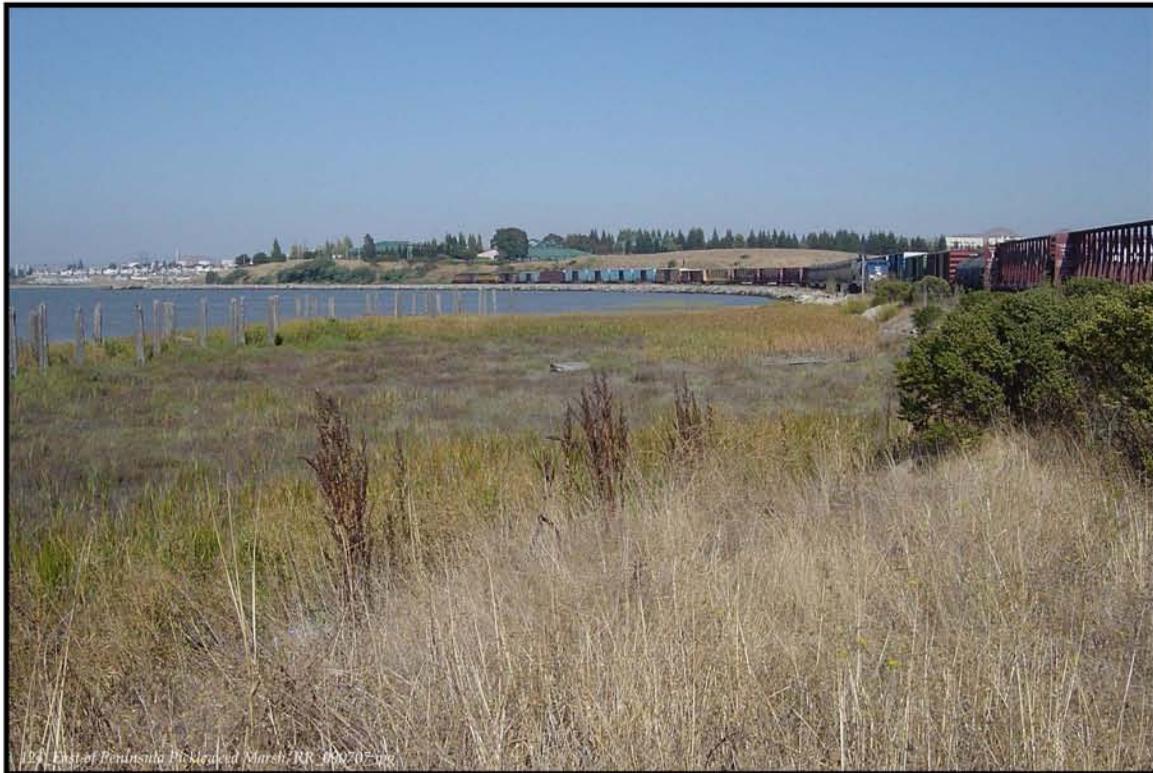
**Photo 1: Tidal Marsh Along East Side of Peninsula, Looking East.
September, 2007.**

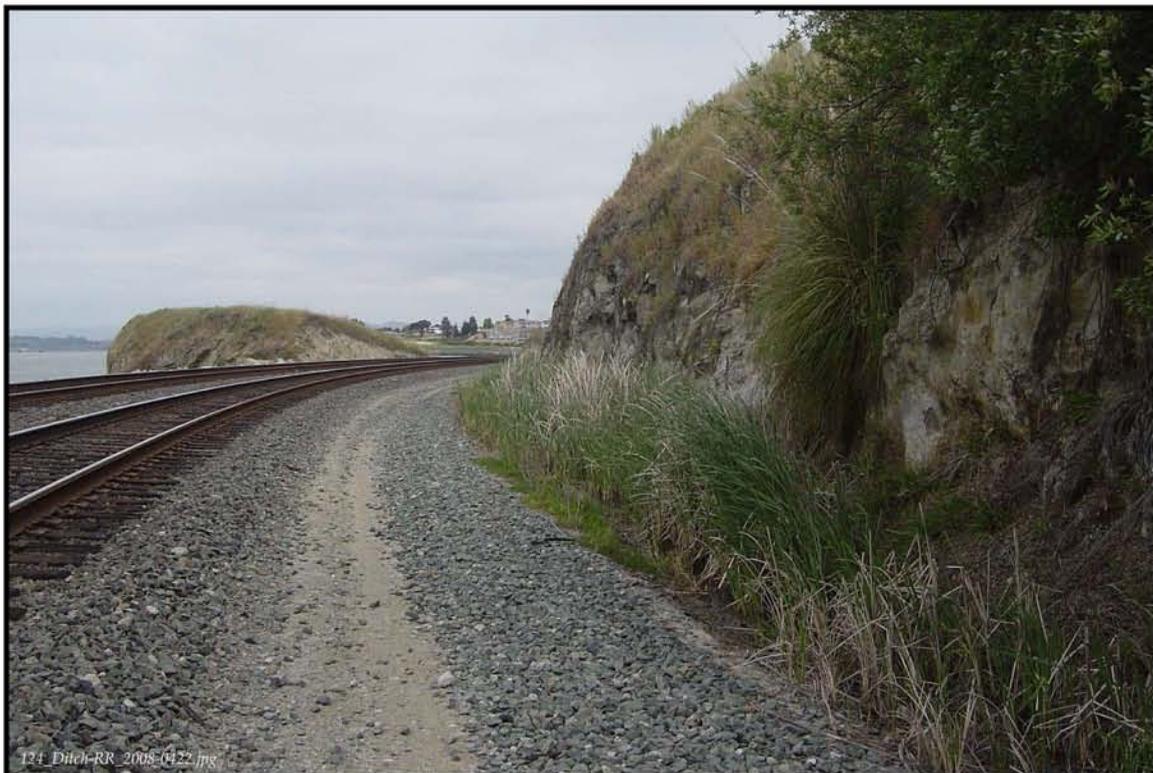
**Photo 2: Wetland Ditch at Northeastern Edge of Project Site.
April, 2008.**

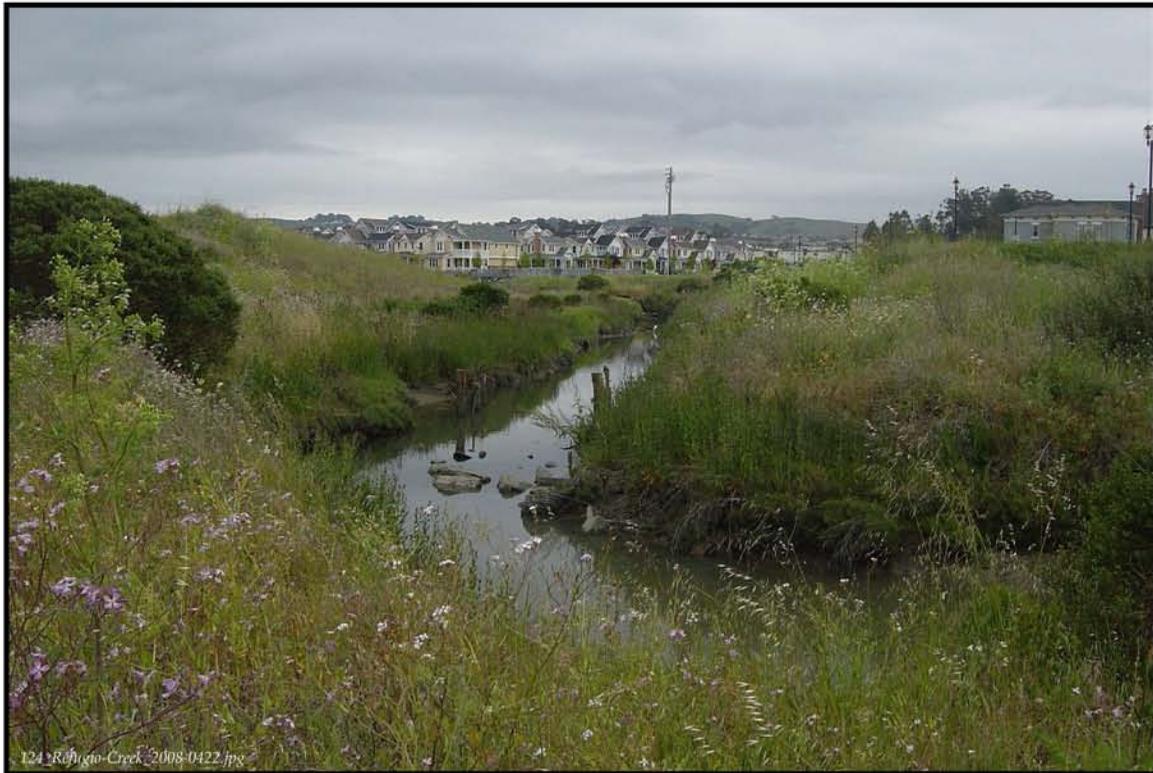
**Photo 3: Bend in Refugio Creek, Central Portion of Project Site.
April, 2008.**

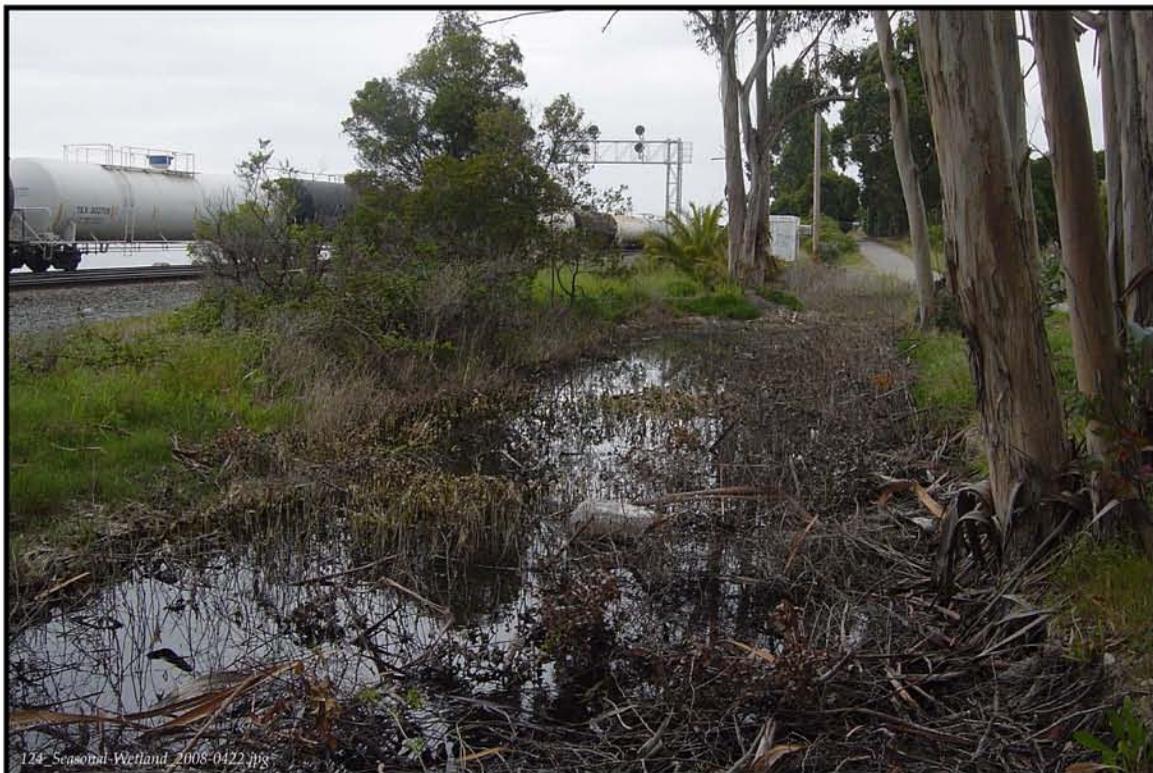
**Photo 4: Seasonal Wetland at Southwestern Edge of Project Site.
April, 2008.**

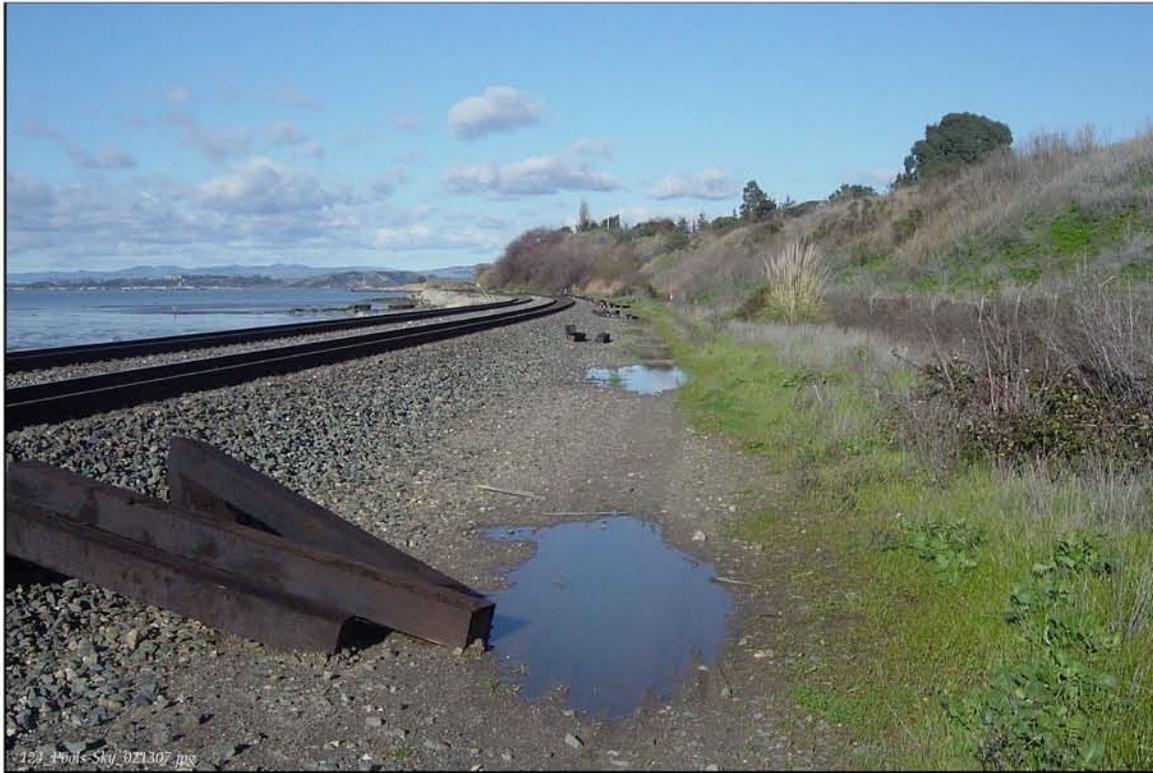
Photo 5: Un-vegetated "Other Waters" at NE Edge of Project Site. February, 2007.

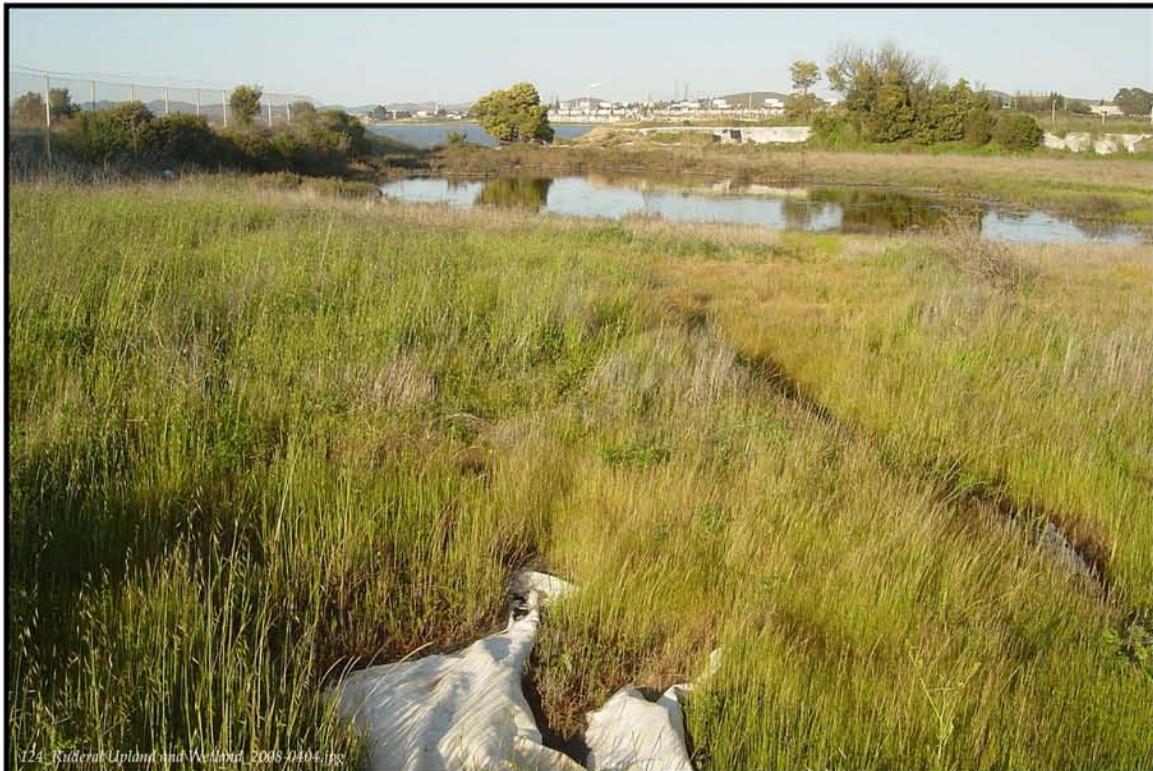
Photo 6: Ruderal Upland and Wetland at Center of Project Area. April, 2007.

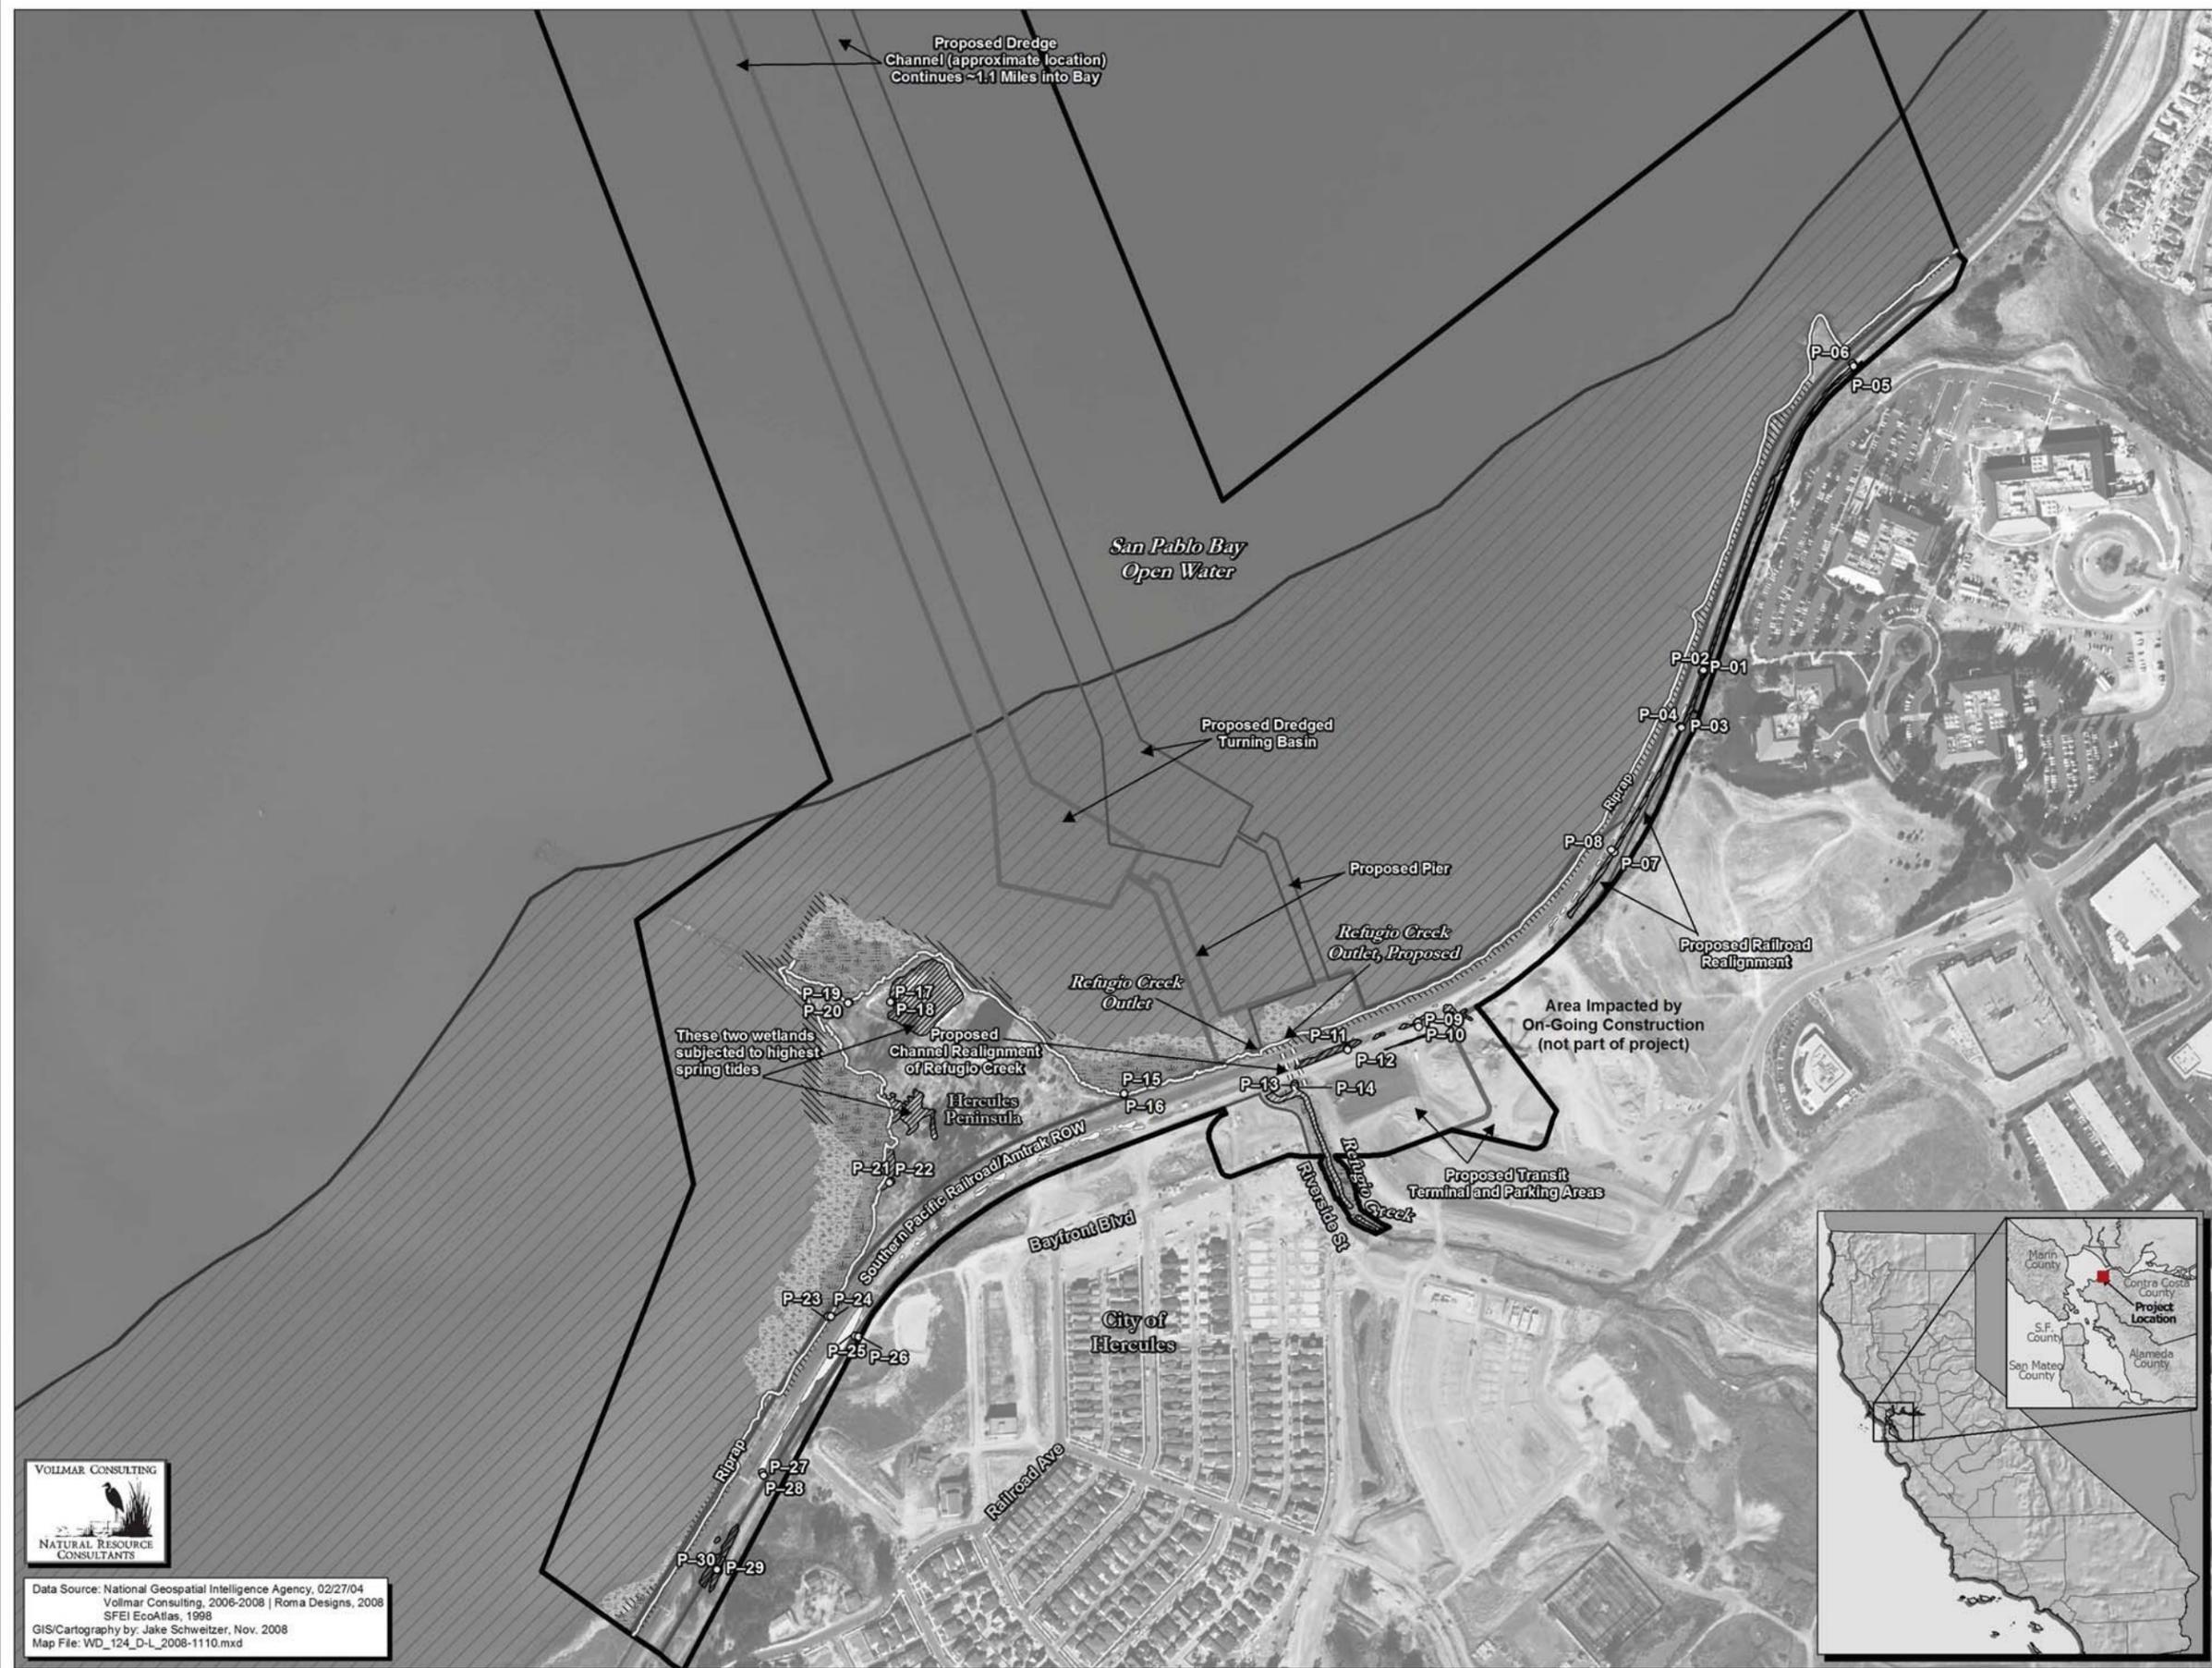
FIGURE 3
Jurisdictional
Waters of the U.S. 2007-2008
 Hercules Intermodal Transit Facility
 Contra Costa County, California

- 1 Odd number = wetland point
- 2 Bay margin; does not include navigable waters of Refugio Creek.
- 3 Un-vegetated seasonal wetlands along RR track
- 4 Refugio Creek is subject to Section 10 as well as Section 404 jurisdiction

Total navigable waters (bayward of mean high water line plus open waters and tidal marsh of Refugio Creek): 371.915 ac.
